**RE: Site Remediation
Former Mill Property
1 Carrington Street
Lincoln, RI**

Alliance Environmental Group, Inc. (AEG) on behalf of FDS Industries, the owner of the above-mentioned property (hereinafter, "Site"), has completed the following letter report summarizing the results of remediation efforts undertaken at the Site from June 3, 2008, to July 15, 2008 with final soil disposal on November 10, 2008. A United States Geological Survey (USGS) Locus map of the Site is attached as Figure 1.

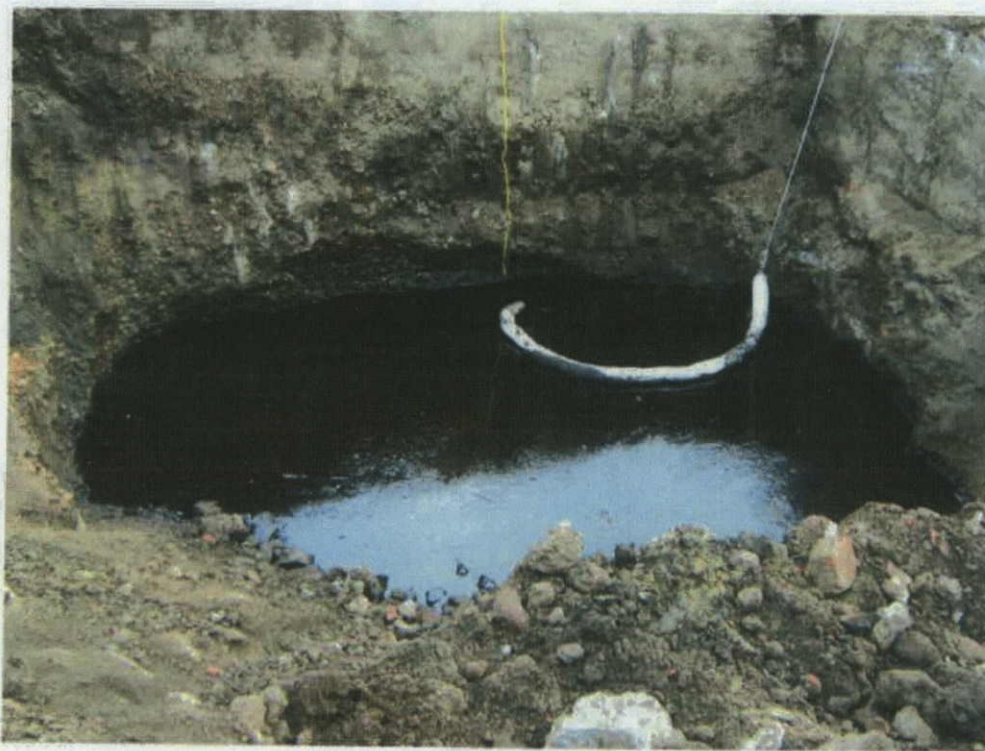
Photo 1: View of excavation with oil layer before skimming, in area of sample AEG-205.

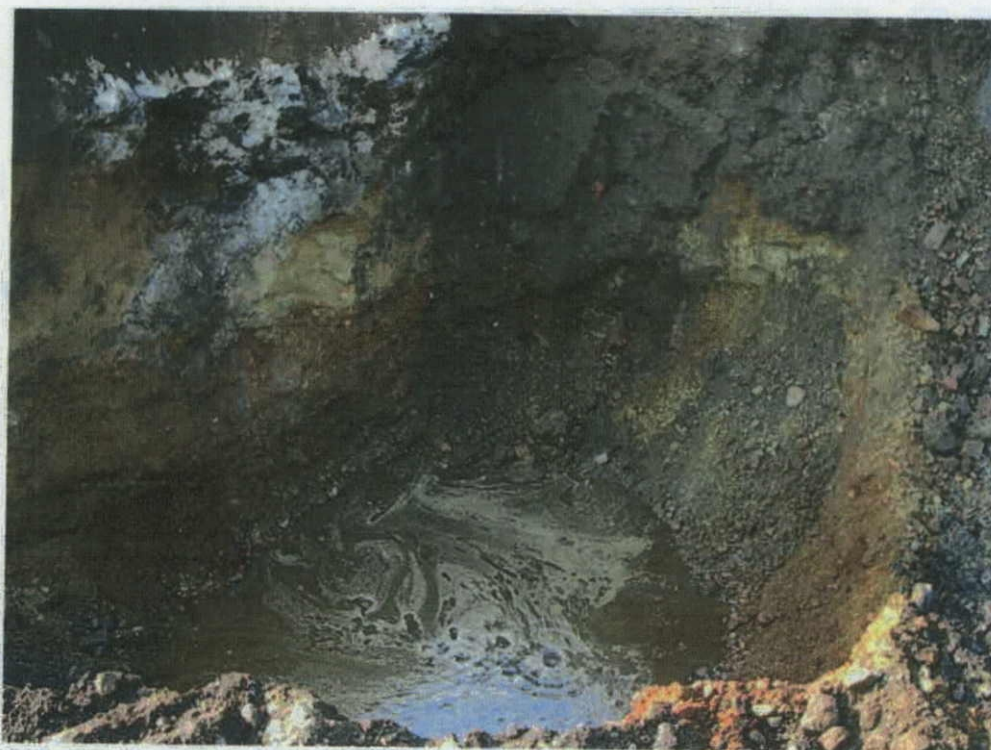
Photo 2: View of excavation in area of sample AEG-206. No visible oil on water.

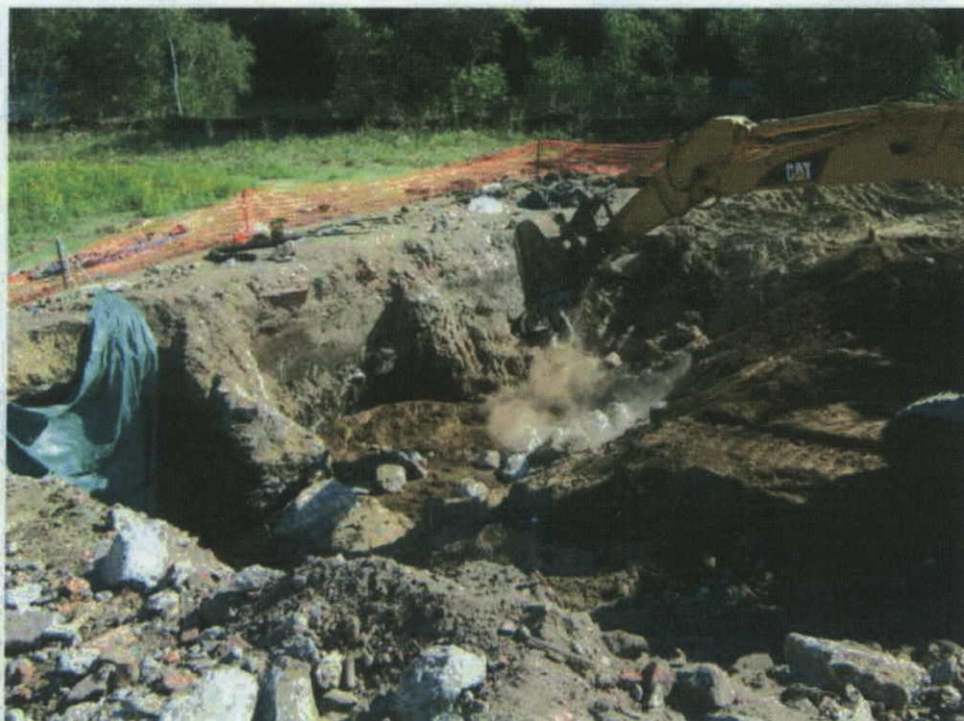
Photo 5: Backfilling of excavation after completion of cleanup.

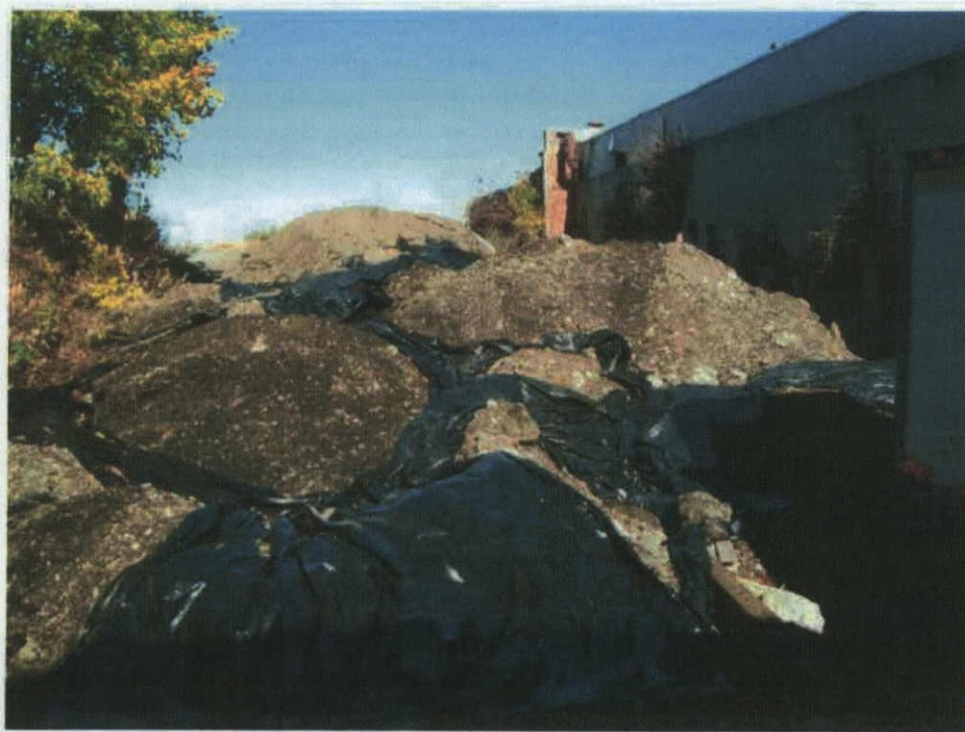
Photo 6: View of contaminated soil pile. Removed to ESMI disposal facility
November 2008

In the course of the excavation, approximately 882 tons of oil-contaminated soil was removed and stored on-site on top of and covered with 6-mil poly until such time as it could be transported off-site to a licensed disposal facility. On October 30, November 7 and November 10, 2008, the material was loaded onto trucks and transported to Environmental Soil Management Inc. (ESMI) in Loudon, New Hampshire for thermal destruction. A Copy of the Contaminated Soil Removal Records is attached as Appendix B and a photo log is attached as Appendix C.
